## **Case Study 110-8**

### **Settlement of Fill Material During Construction of an Addition to a Bank**

Atlanta, Georgia

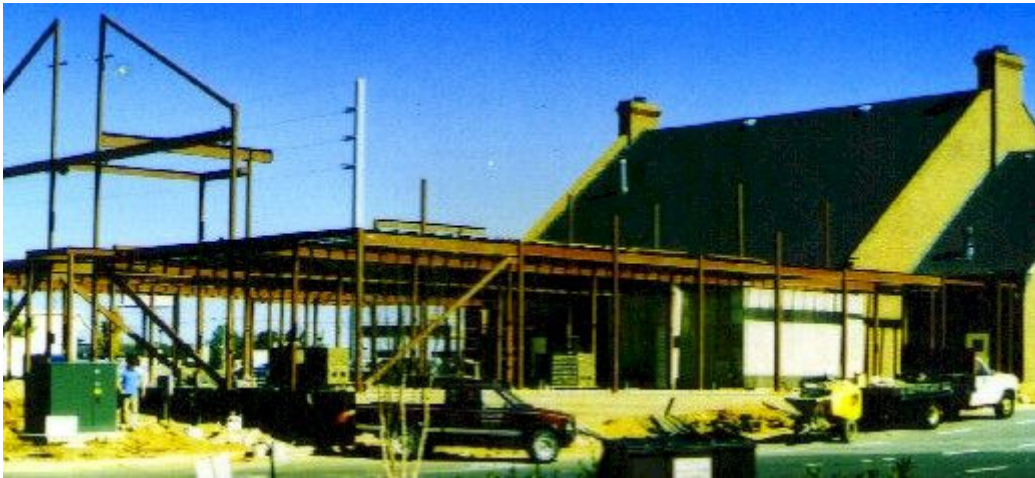
The site required compacted fill prior to construction of an addition to the bank. When the contractor noticed cracks appearing in recently installed masonry, soil tests were ordered along the problem area. The results showed that the compacted fill was not extended beyond the area of construction.

The construction schedule required that steel framing be installed, but the structure was showing serious distress. Could the building be saved? Would the structure have to be demolished and rebuilt? What about the budget and time schedule?

Atlas Piers of Atlanta installed ATLAS RESISTANCE PIERS along the side and at the back of the bank addition. Construction continued on schedule saving the customer time and money!

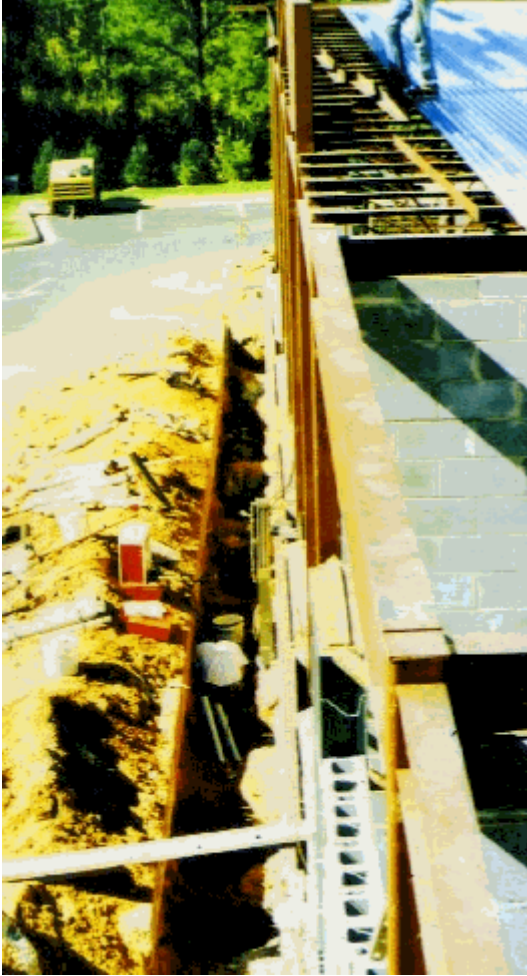
The photograph at the left shows a fracture in the masonry and in the concrete floor.

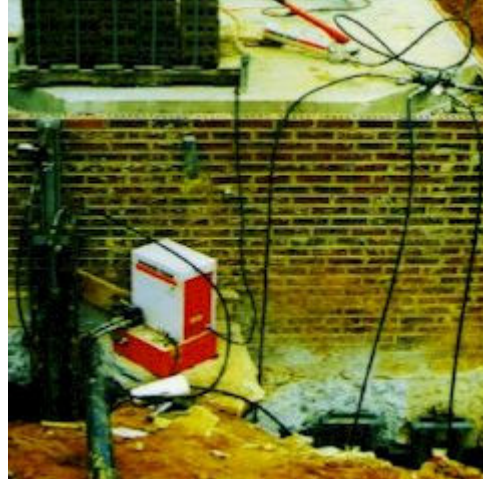
The photograph at right shows how the structure is supported and restored using the ATLAS RESISTANCE PIER. The hydraulic hand pump can be seen on the concrete floor. A manifold directs the pressure to several piers for gentle and even support of the structure.

Note that an ATLAS RESISTANCE PIER is being installed at the left side of the photograph. The hydraulic pump and pier installation equipment are visible.

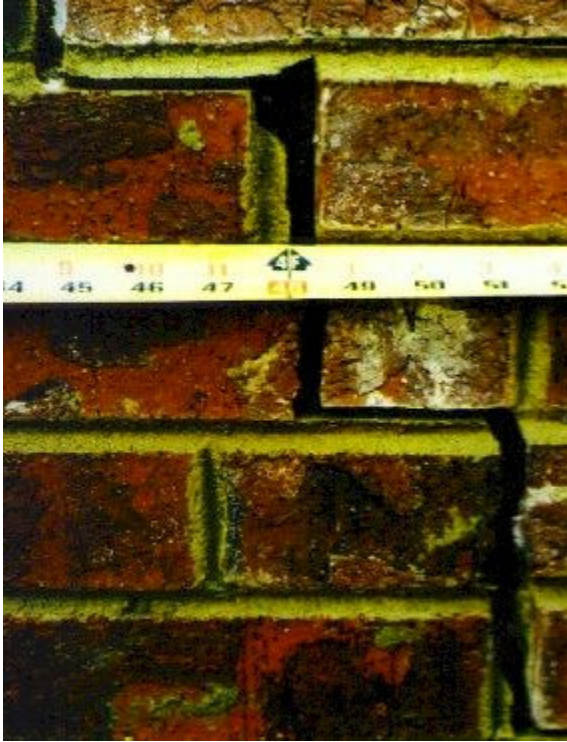
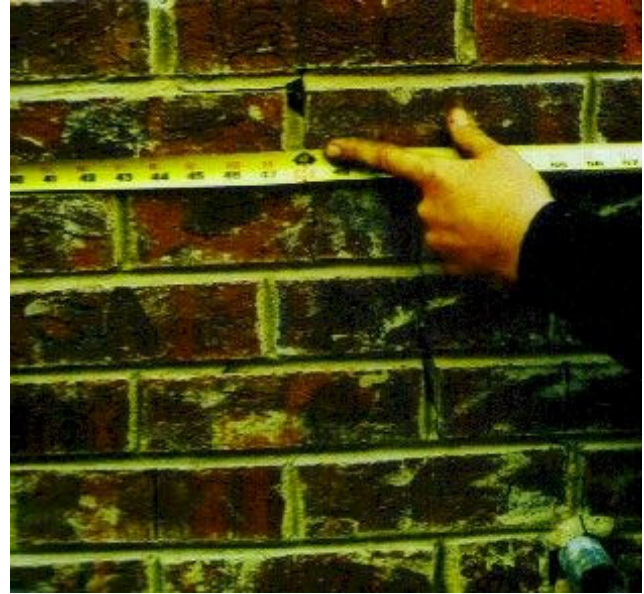
**SUCCESS!** These photographs show the masonry fracture before and after the foundation was restored with ATLAS RESISTANCE PIERS. The crack which measured  $\frac{3}{8}$  inch was completely closed.
