## Case Study 551-3

# ATLAS RESISTANCE PIERS

## Damaged Foundation Drains Cause 1-1/2 Inch Settlement of New House

Snowmass Village, Colorado

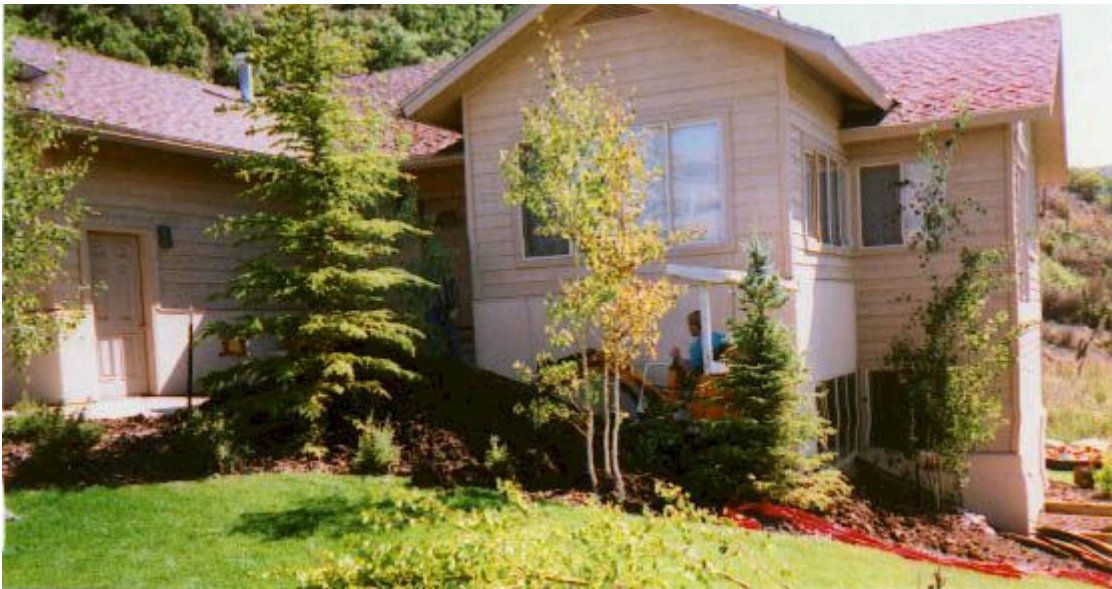
### DAMAGED DRAIN LINE CAUSE SETTLEMENT!

**Cause of the Problem:** During final grading, the contractor crushed the foundation drain lines near the entry. Water was trapped adjacent to the footing. As a result, water saturated the soil and caused the footing to settle at the front wing of the house.

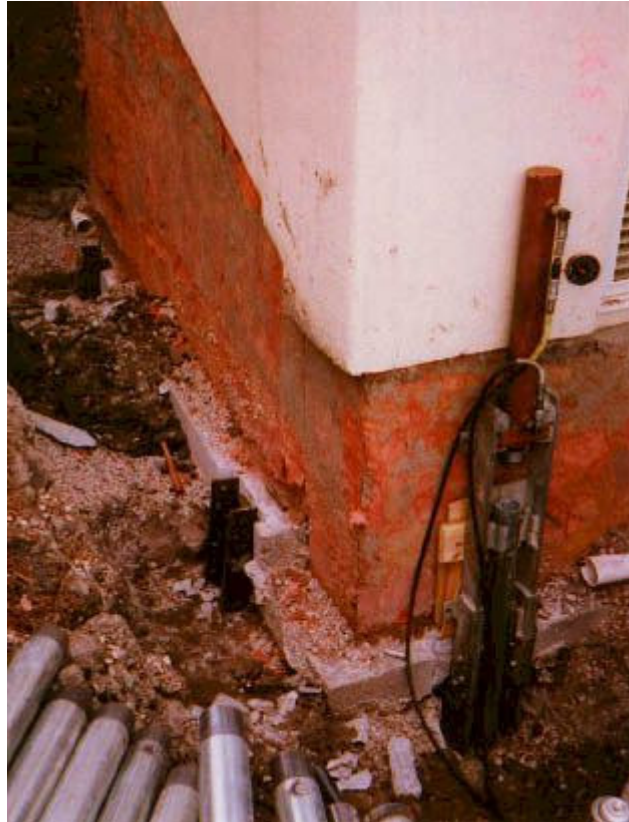
The photograph above shows pier number 1 being driven at the front corner of the structure. Piers 2 and 3 have already been installed.

After excavation, the footing was notched to place the structural load directly over the **ATLAS RESISTANCE PIERS**. Then the pier pipe was driven vertically to a suitable bearing stratum and tested to an average force of 40,000 pounds before the structure was restored.

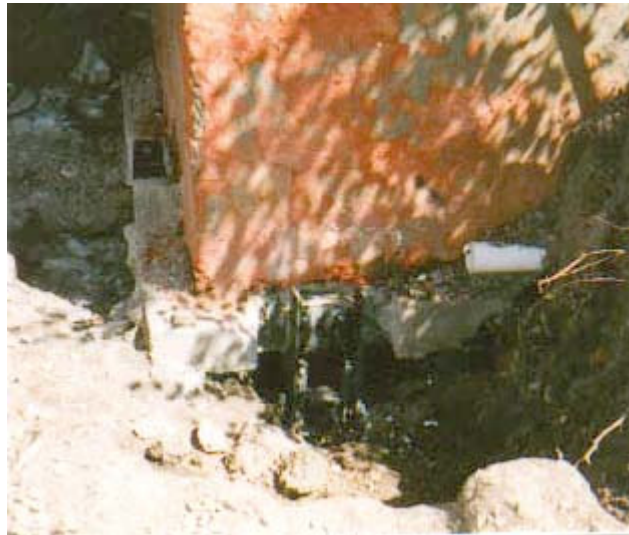
The photo at right shows the project after lifting and prior to backfill.

Once all of the **ATLAS RESISTANCE PIERS** were driven to a suitable load bearing stratum and tested, the structure was gently and evenly lifted using multiple hydraulic rams, a manifold assembly, and a hand pump.
