A CASE HISTORY

Vibration deadlines 500,000-pound forge press

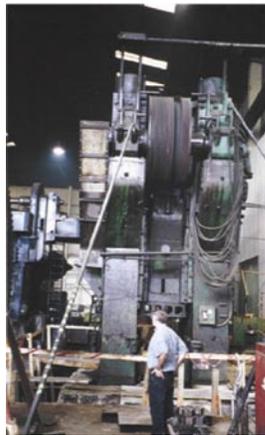
Deterioration of the concrete under the machine base was severe and led to excessive mechanical wear to the press.

At left, Atlas Resistance® Piers were installed around the perimeter of the footing of this 50-foot tall forge press that weighs 500,000 pounds!

This existing and deteriorating footing was "wrapped" with structural bands. Then, three foot lengths of 6x6 WF beam with mounting plates for the Atlas Resistance® Piers were welded to the bands for load transfer.

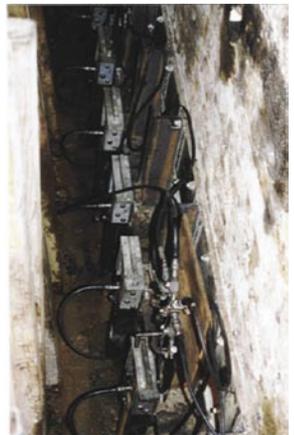
At right, photo shows the configuration used to apply an equal force to each of the 32 Atlas Resistance® Piers. Each pier was fitted with a 50,000-pound ram.

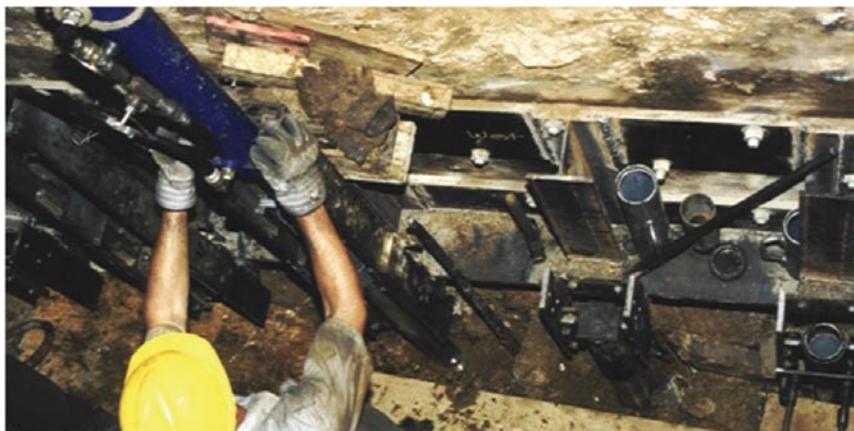
At left, a technician installs an Atlas Resistance® Pier using quiet and portable hydraulic equipment. Each pier was "proof loaded" to an average 65,200 lbs. at a depth of 100 feet! Notice the additional structural support provided to transfer the load to the damaged concrete footing.
