CHANCE Atlas Resistance® Pier Civil Construction FOUNDATION REPORT

A CASE HISTORY

Warehouse foundation settlement recovered 22 inches

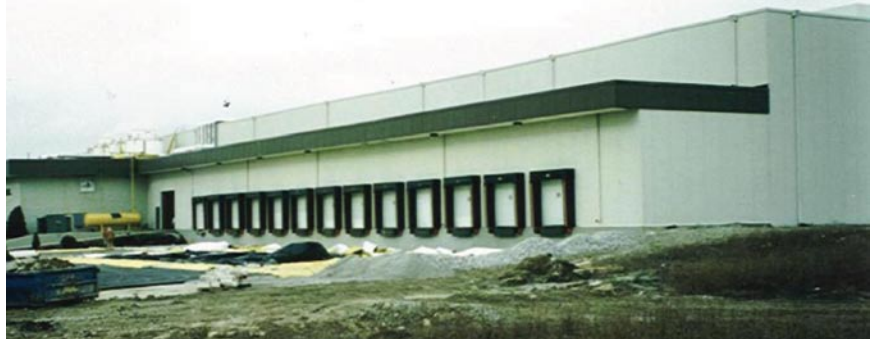
This is a view of the front of the structure. The loading dock shown here had settled 8 inches. Some areas at the right side of this building suffered settlement in excess of 22 inches!

The management and maintenance department of the company chose AtlasResistance® Continuous Lift Piers to solve the settlement and structural instability problems. Elevation measurements made prior to restoration revealed that the foundation settlement was 8 inches at the dock area and in excess of 22 inches along the side of the structure!

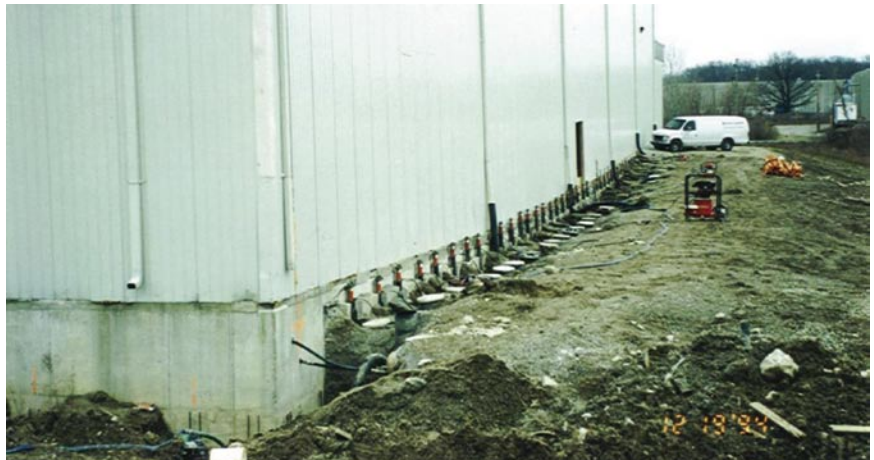
The photo above shows the right side being carefully and gently lifted. Note the hydraulic rams on each pier.

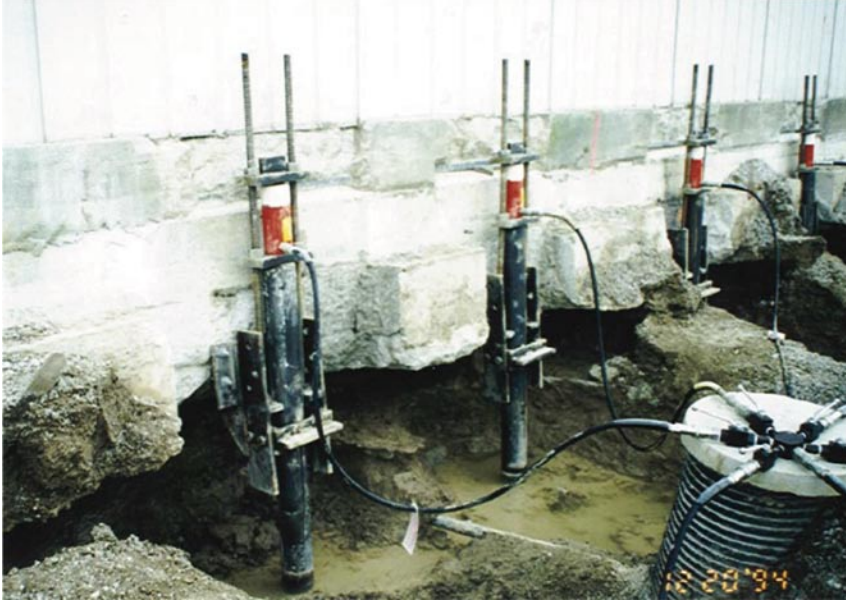
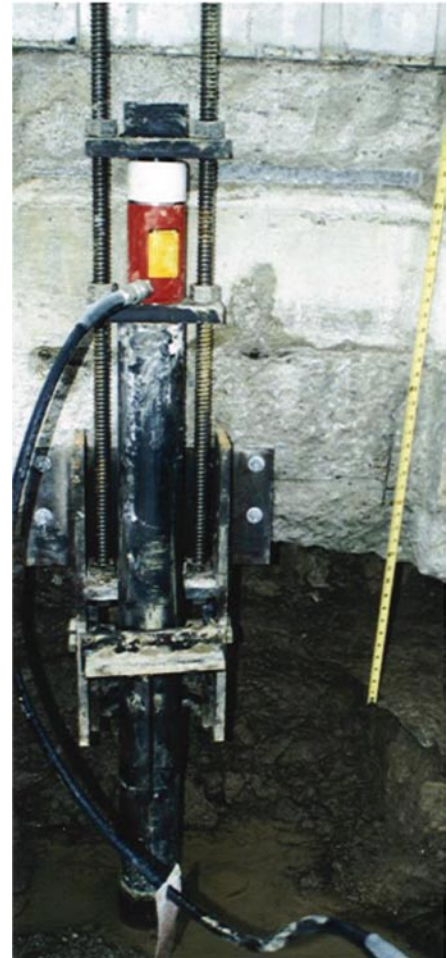
These photographs show the restoration process using Atlas Resistance® Continuous Lift Piers. The recovery at this point is approximately 50 percent. The tape measure at right shows a lift of approximately 11 inches.

Notice how the piers were all connected together by manifolds. Each hydraulic ram was actuated at the same time to provide a gentle, even lift.
