# "I AM AFRAID THAT MY CHIMNEY WILL COLLAPSE!"

**THE SOLUTION: ATLAS RESISTANCE PIERS!  
STABILIZED AND RESTORED THE CHIMNEY AND FOUNDATION!**

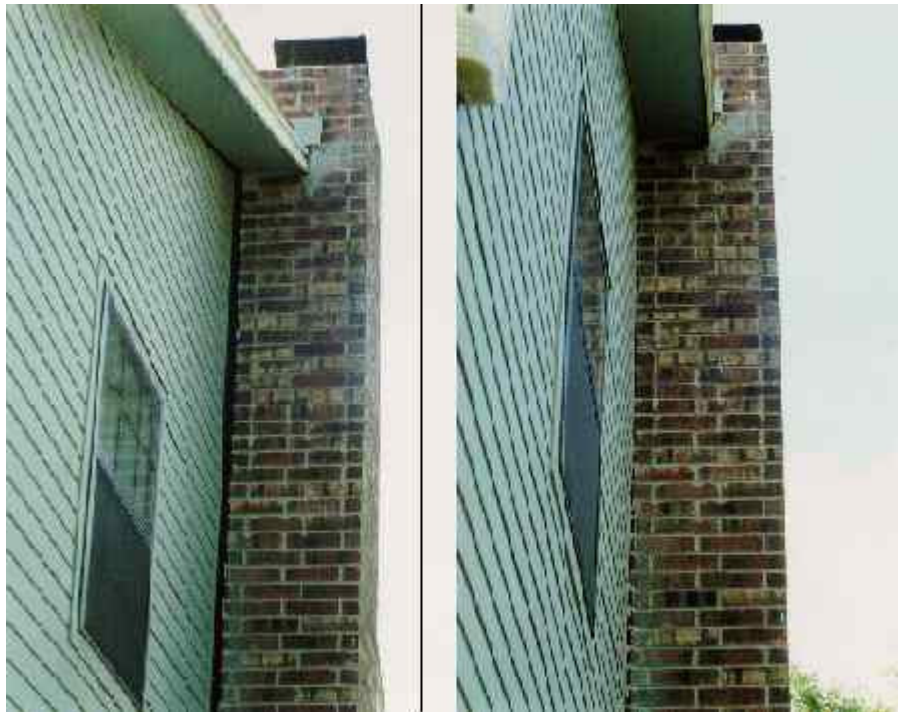
A Claremore, Oklahoma, homeowner was very concerned that the chimney on the side of his house would come crashing down and injure someone. The movement of the chimney had allowed a family of sparrows to take up residence in the attic.

The homeowner went on to say that stains were visible on the ceiling. The flashing connecting from the chimney to the roof had failed and rain was penetrating the roof. Could the chimney be saved, or must it be torn down and a new chimney built?

**Before Restoration and After Restored with ATLAS RESISTANCE PIERS**

Atlas Piers of Tulsa, Inc. installed eight **ATLAS RESISTANCE PIERS** around the chimney and along the adjacent perimeter wall. Not only did the **ATLAS RESISTANCE PIERS** provide stabilization, the piers were used to raise the foundation **one inch** to restore the chimney to vertical and to level the foundation.

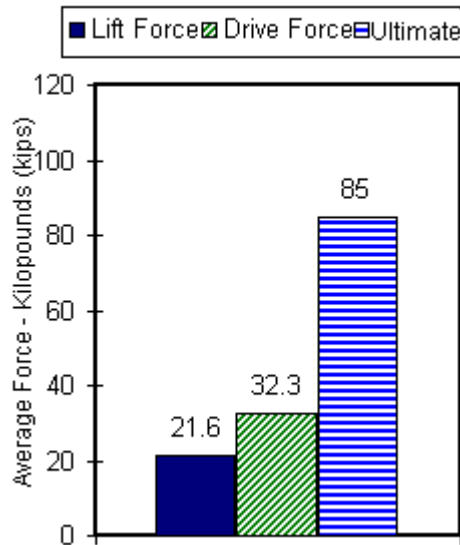
### Atlas Resistance Piers Lift Force vs. Drive Force & Ultimate

PROJECT SUMMARY	
Installed By:	<b>Atlas Piers of Tulsa, Inc.</b>
Number of Piers:	8
Part Number:	AP2S-3500
Avg. Pier Depth:	16 feet
Avg. Load per Pier:	21,630 pounds
Avg. Drive Force:	32,331 pounds
Ultimate Capacity:	85,000 pounds
Amount of Lift:	1 in.
Factor of Safety:	1.49 : 1 (Drive to Lift)
(Averages)	3.93 : 1 (Ultimate to Lift)

The chart above shows the ultimate pier capacity is **over four times** the average pier load. The average driving force is **over 60 percent** above the average pier load.

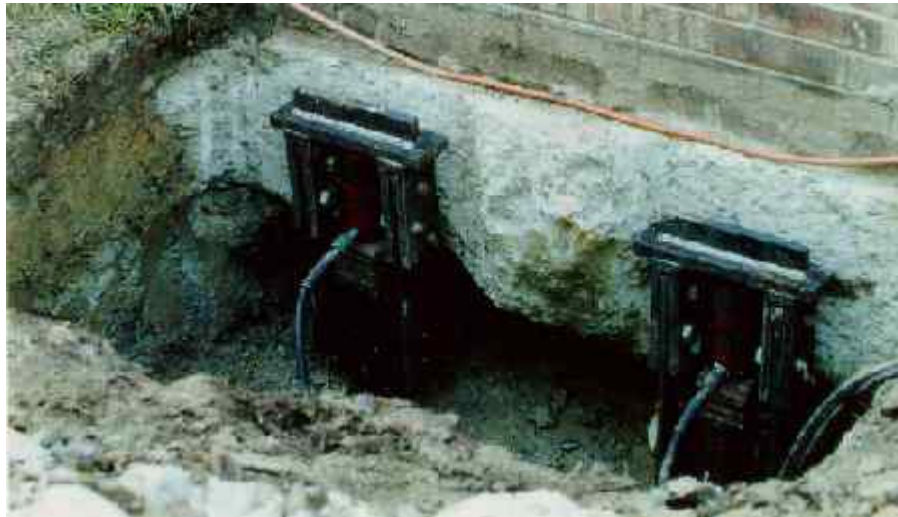
This photograph shows the two Atlas AP2S-3500 Piers used to restore the chimney. The hydraulic rams are actuated together and are used to lift the structure. Once restored, the rams are removed.

Atlas Piers of Tulsa, Inc. installed **Atlas Resistance Piers** around the chimney and adjacent perimeter footing in order to stabilize and restore the structure. The piers were driven to a bearing stratum at a depth of approximately sixteen feet. The restoration process removed one inch of settlement and returned the chimney to vertical!
