A CASE HISTORY

Foundation Fails in Corrosive Soil

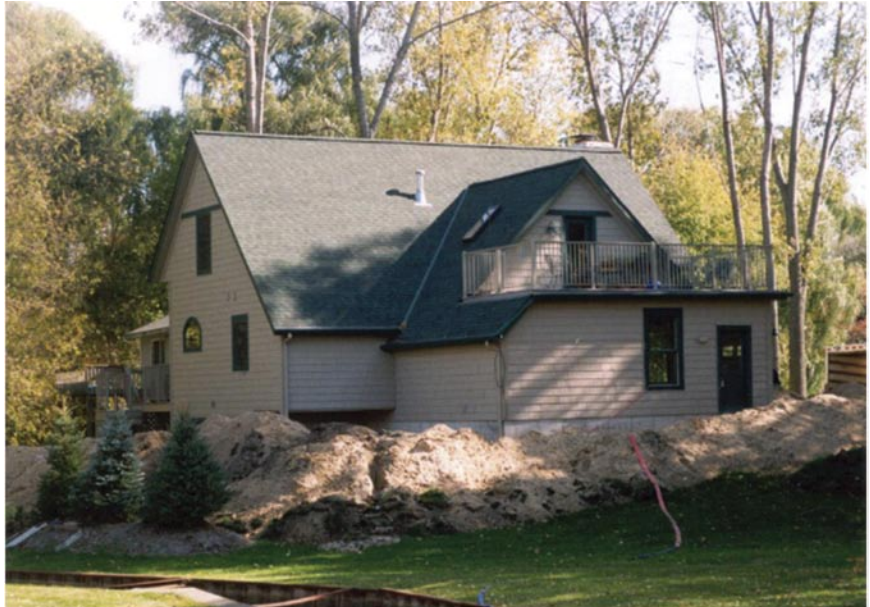
In Holland, MI, this two year old split level house was constructed on a foundation of 19 wood piles. The lot was built up as much as 8 feet on what was supposed to have been engineered fill. The stem wall was cast-in-place reinforced concrete and the house is of wood frame construction. The construction techniques were found to be rather erratic. Many interior grade beams were either incorrectly located or did not exist. In some locations large "blobs" of concrete were found instead of a formed and reinforced concrete grade beam.

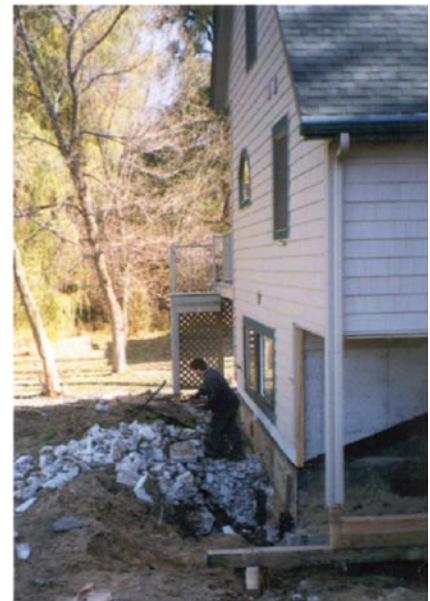
A technician works to remove rubble along the side of the home. Two Atlas Resistance® Continuous Lift Piers are visible in the foreground.

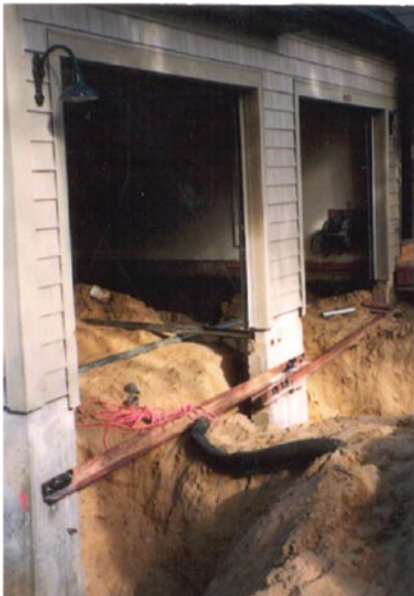
At the garage, the floor was

removed and revealed that concrete beams shown on the original design were not constructed. Steel angles, steel beams and helical foundation piers were used to stabilize the garage during restoration.

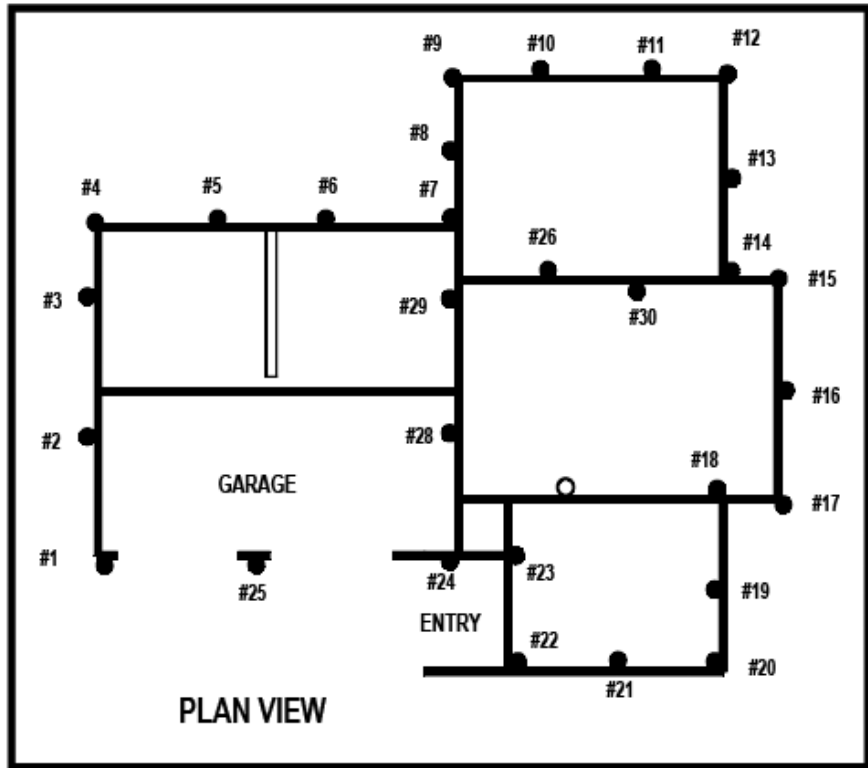
Above, side of the garage showing installed piers No. 1, 2, 3 and 4.

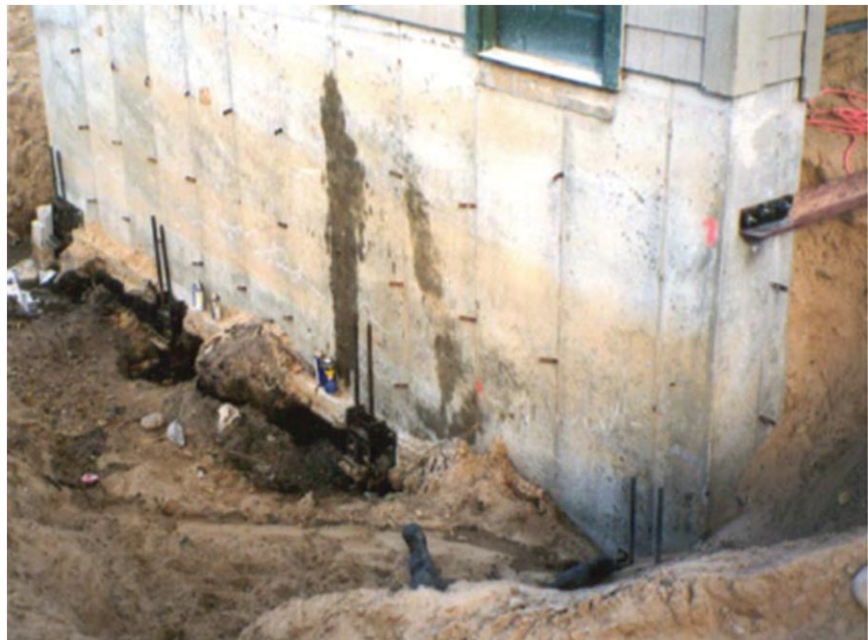
Photo at left illustrates how the contractor stabilized the garage structure with steel during pier installation and restoration.

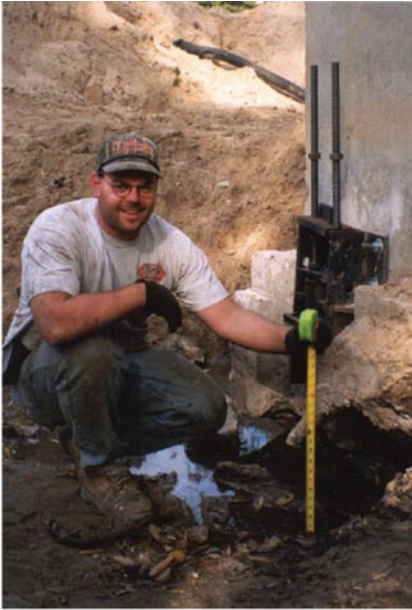
Above, a worker demonstrates the void created when the structure was lifted 13 inches at one of the Atlas Resistance® Continuous Lift Piers.

Following the lift, the void was filled with 14 yards of grout!

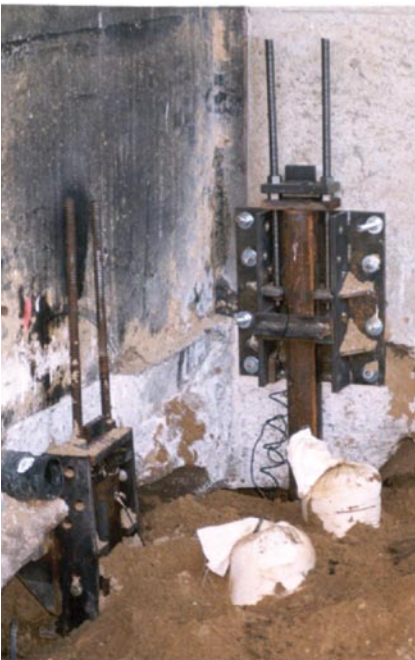
Below, an Atlas Resistance® Standard Continuous Lift Pier and a Continuous Lift Plate Pier are shown fully installed, with the load transferred to the pier and with the magnesium anodes attached.

The engineer recommended that a sacrificial anode system be installed to protect the pier system. Each pier was electrically connected to a 50 pound magnesium anode. Engineering calculations show that this system will provide a useful life in excess of 50 years!

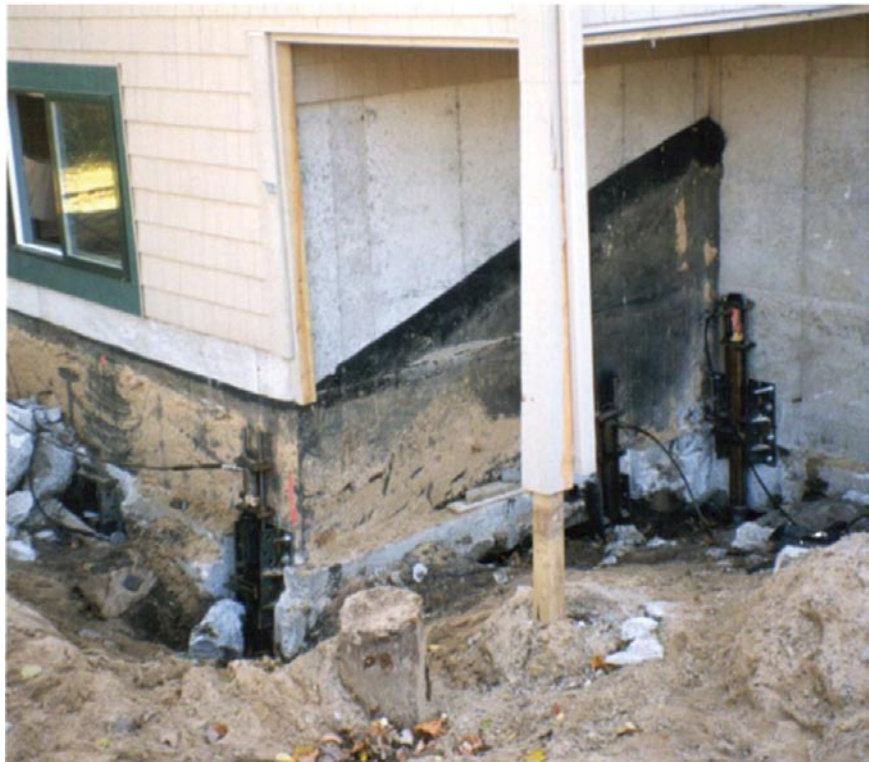
Piers 7, 8, 9 and 10 at the rear of the house near the garage during the lift. Notice the 25-ton hydraulic rams installed on each pier.

The structure was carefully lifted and was brought to virtually level. The piers were loaded and the structure lifted using 25 ton hydraulic rams that were connected to manifolds and actuated with hand pumps. One of the features of the Atlas Resistance® Continuous Lift Pier is that hydraulic rams with short strokes may be used in conjunction with the Pier to generate very large lifts.
