"USELESS WATER STORAGE TANK RESTORED TO SERVICE QUICKLY AND AT LOW COST!"

**THE SOLUTION: ATLAS RESISTANCE PIERS!
STABILIZED AND RESTORED THE WATER TANK!**

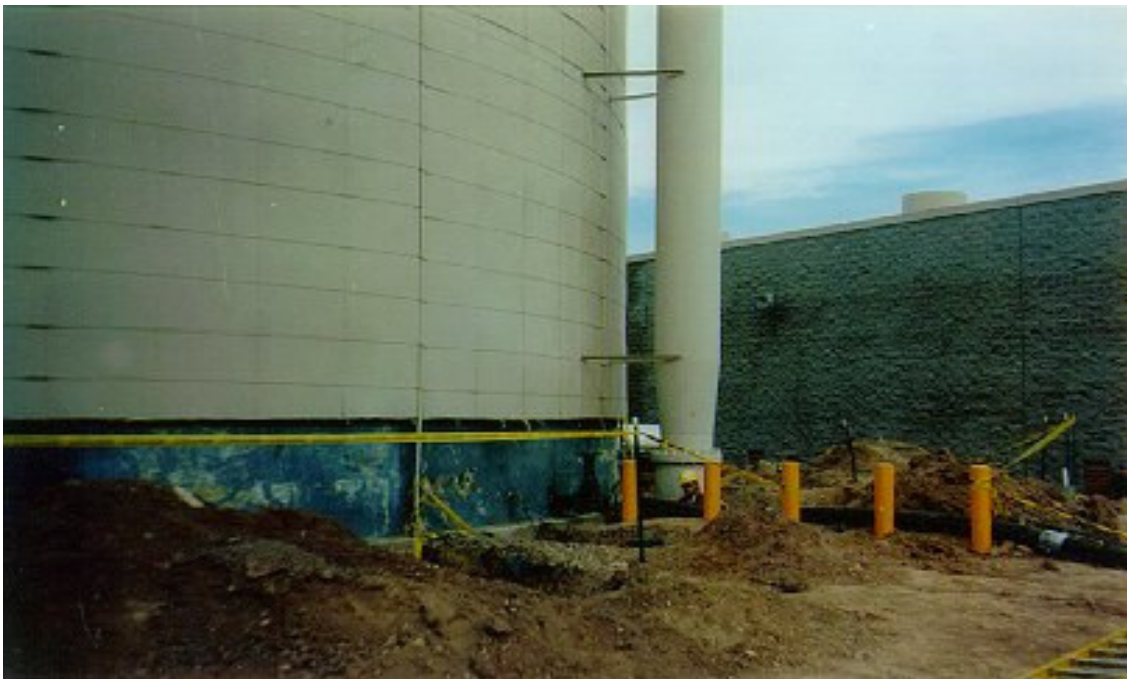
An 880,000-gallon water storage tank supplying a small town in eastern Utah was rendered useless due to settlement of the foundation. The concrete foundation for the tank was of good design with a 16-inch-thick stem wall situated 7 feet into the soil.

The location for the tank required cutting and filling the site. The material on the fill side of the site was compacted to specifications, but the soil still failed largely due to drainage problems around the perimeter of the foundation.

Atlas Piers of Utah, Inc. installed 16 ATLAS RESISTANCE PIERS on the perimeter of the tank foundation. The ATLAS RESISTANCE PIERS raised the foundation as much as 10-1/2 inches to restore the water storage tank. After the voids under the foundation were filled with grout and drainage corrections accomplished, the tank was returned to service.

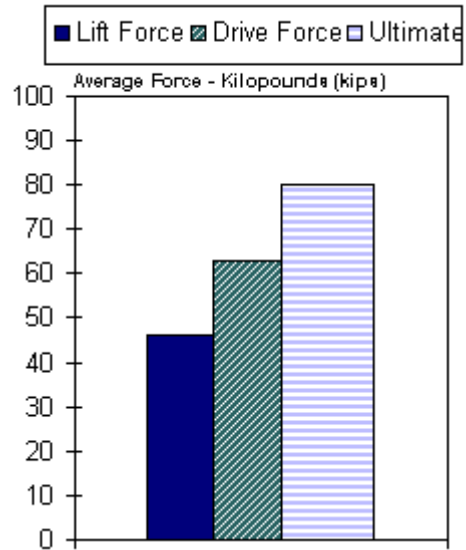
Atlas Resistance Piers Lift Force vs. Drive Force & Ultimate

The chart above shows the ultimate pier capacity is **nearly two times** the average pier load. The average driving force is **over 34 percent** above the average pier load.

PROJECT SUMMARY	
Installed By:	Atlas Piers of Utah, Inc.
Number of Piers:	16
Part Number:	AP3S-3500
Avg. Pier Depth:	27 ft.
Avg. Load per Pier:	46,350
Avg. Drive Force:	62,175 lbs.
Ultimate Capacity:	80,000 lbs.
Amount of Lift:	Up to 10-1/2 inches
Factor of Safety:	1.34 : 1 (Drive to Lift)
(Averages)	1.73 : 1 (Ultimate to Lift)

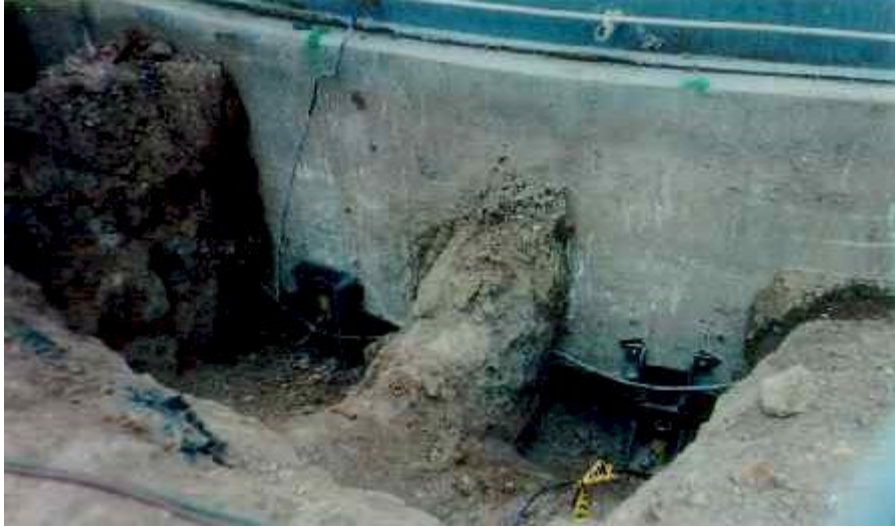
This photo shows two of the ATLAS RESISTANCE PIERS attached to the stem wall after the foundation was restored.

Atlas Piers of Utah, Inc. installed **ATLAS RESISTANCE PIERS** around the perimeter in the area of distress in order to restore and stabilize the structure. The restoration process removed up to 10-1/2 inches of settlement quickly at low cost.
