### A CASE HISTORY

### Foundation "Back in the Game"

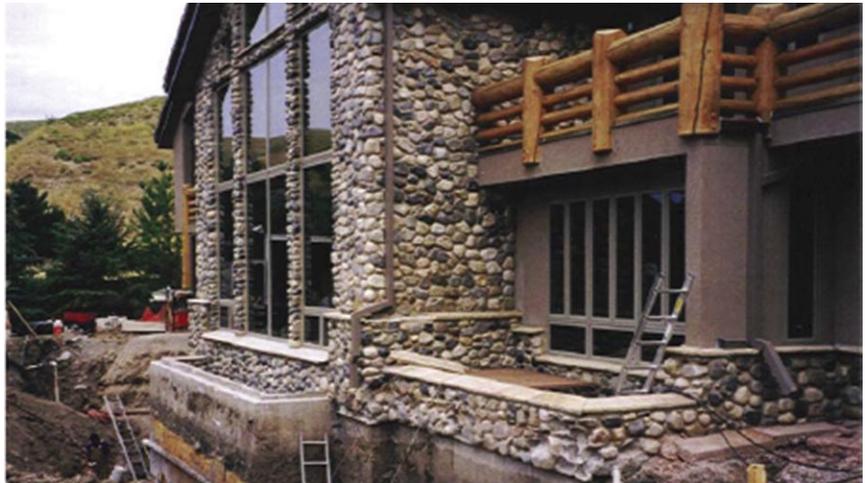
The 12-foot tall foundation wall

developed open fractures at several locations. The photo at right shows one of these fractures and the distress to the rock veneer above it. The floor in the great room developed a slope as indicated on the sketch next page. The differential settlement across the room was approximately 1-1/2 inches. When considering the attached window wells, foundation

Each Atlas Resistance® Pier was driven to a suitable bearing stratum and tested to a load greater than required for support of the structure. After each pier was load tested, the structural load was gently and evenly transferred to the piers. The foundation was restored to as close to the original elevation as the construction would allow.

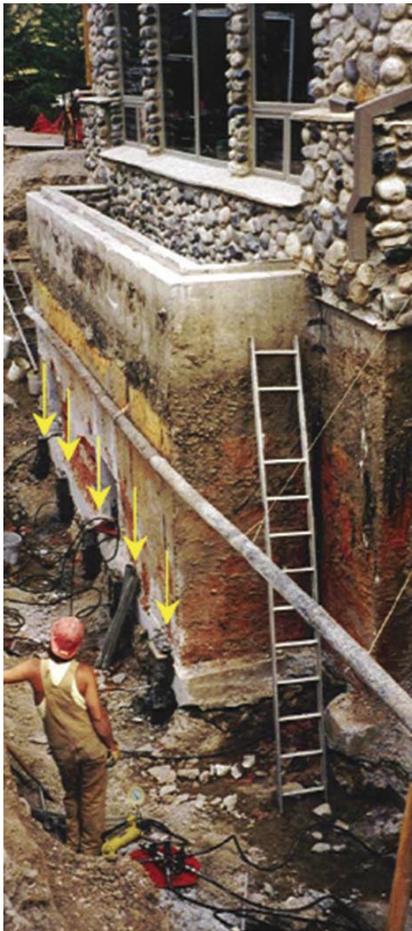
Photograph at left shows the excavation to expose the footing. Notice the installer mounted five Atlas Resistance® Piers to the stem wall for the window wells near the great room.

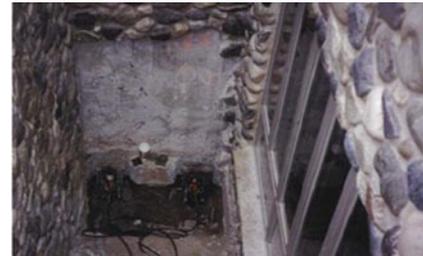
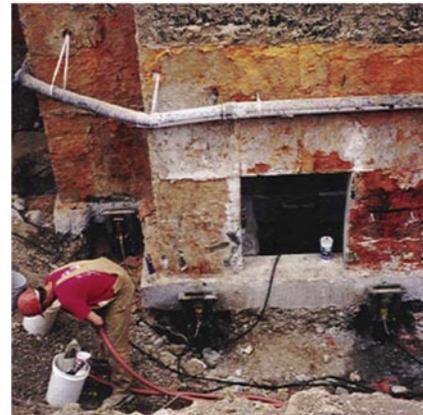
Photographs at right show how the Atlas Resistance® Piers were installed inside of the window well. In order to gain access to the footing, the gravel fill at the window well was removed. Access holes were cut through the wall at the window well to gain access as shown in the lower right photograph.

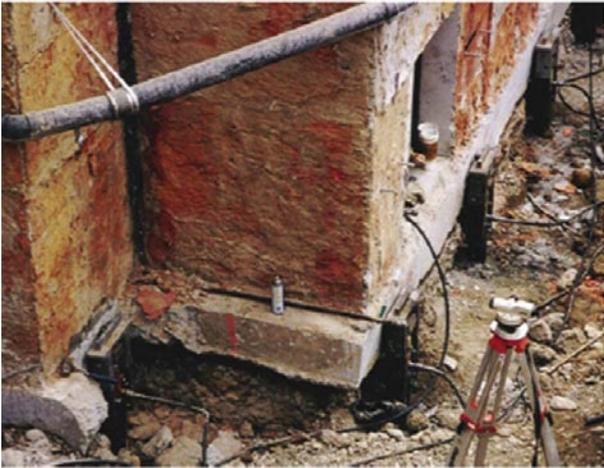
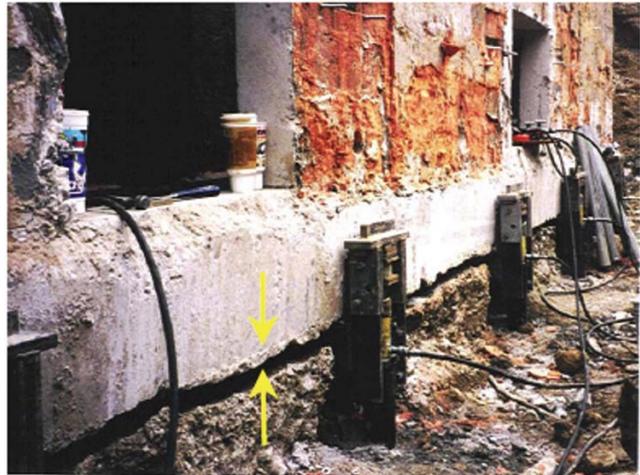
The photographs above show Atlas Resistance® Piers with hydraulic rams attached during the restoration of the structure. Notice the photo at right shows a lift of over 2 inches at the window well.

After all of the Atlas Resistance® Piers were installed and driven to a verified bearing stratum, the piers were all loaded at the same time using hydraulic rams connected to manifolds that directed equal pressure to each pier. As the load was transferred

from the footing and to the pier, the structure was restored to the original elevation. The force applied to each Atlas Resistance® Pier was recorded during restoration. Later, the actual installed depth and the factor of safety was calculated for each pier.

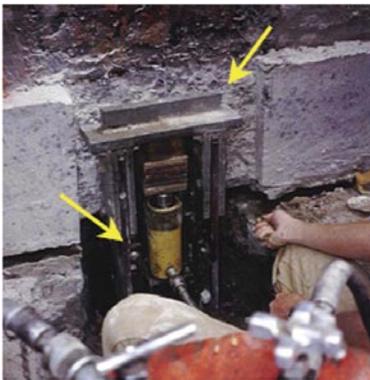
Atlas Resistance® Piers were quickly and easily installed from inside and outside of the structure. The photograph at left shows how the existing footing was notched to allow an Atlas Resistance® Pier to be installed against the stem wall. The Pier Bracket, Driving Stand, Hydraulic Cylinder and Pier Pipe were all carefully aligned during installation to insure a vertical support for the structure.

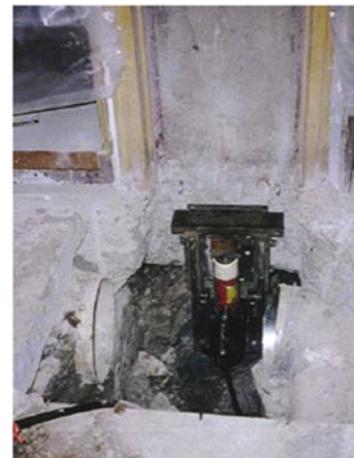
The two silver color Pier Pins located on either side of the yellow hydraulic cylinder. These hardened pins are loaded in double shear. The desired elevation was maintained by the installation of small zinc plated Shims between the Top Pier Platform (located below the yellow ram) and the Pier Pins. After the installation of the Shims and Pier Pins, the galvanized Lift Head and Hydraulic Ram were removed.

The right photograph shows one of the Atlas Resistance® 2-Piece Modified Piers that were installed from the inside of the structure. Notice that this Pier installation required only a small opening in the concrete floor.

After each Atlas Resistance® Pier was loaded and the structure restored, Pier Pins and Shims were installed at each pier location to maintain the desired eleva-

tion after the hydraulic rams were removed. The structure was successfully restored and the owner was extremely pleased with the results.
