A CASE HISTORY

Foundation Fails in Corrosive Soil

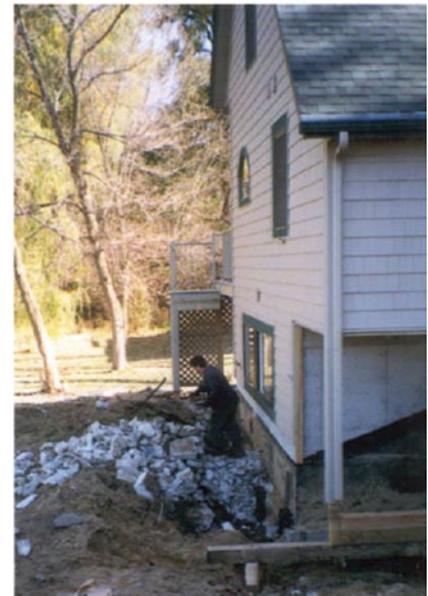
A technician works to remove rubble along the side of the home. Two Atlas Resistance® Continuous Lift Piers are visible in the foreground.

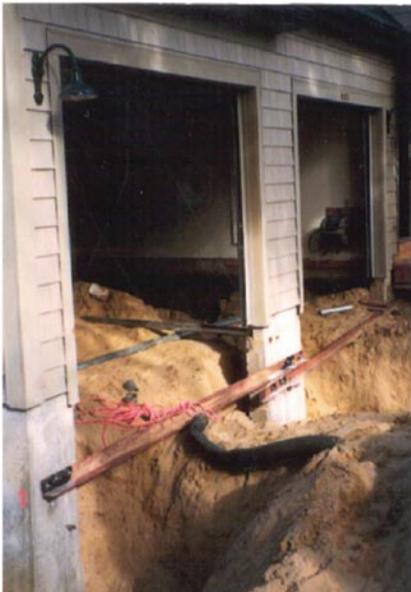
Photo at left illustrates how the contractor stabilized the garage structure with steel during pier installation and restoration.

removed and revealed that concrete beams shown on the original design were not constructed. Steel angles, steel beams and helical foundation piers were used to stabilize the garage during restoration.

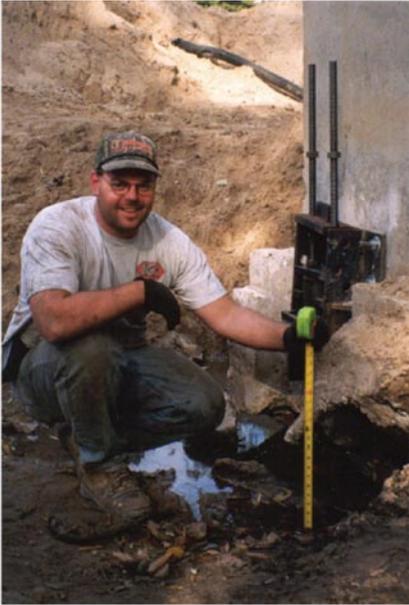
Above, a worker demonstrates the void created when the structure was lifted 13 inches at one of the Atlas Resistance® Continuous Lift Piers.

Following the lift, the void was filled with 14 yards of grout!

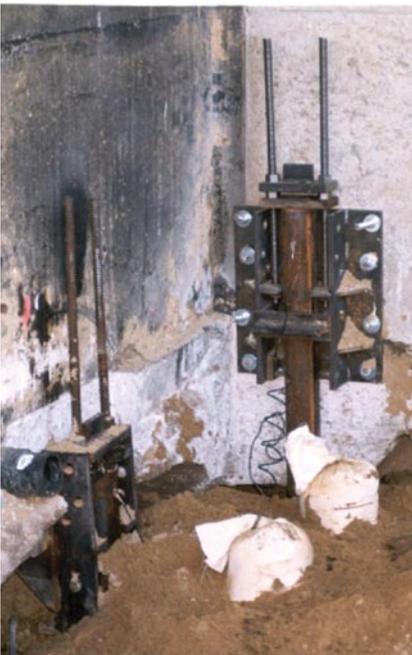
Below, an Atlas Resistance® Standard Continuous Lift Pier and a Continuous Lift Plate Pier are shown fully installed, with the load transferred to the pier and with the magnesium anodes attached.

The engineer recommended that a sacrificial anode system be installed to protect the pier system. Each pier was electrically connected to a 50 pound magnesium anode. Engineering calculations show that this system will provide a useful life in excess of 50 years!

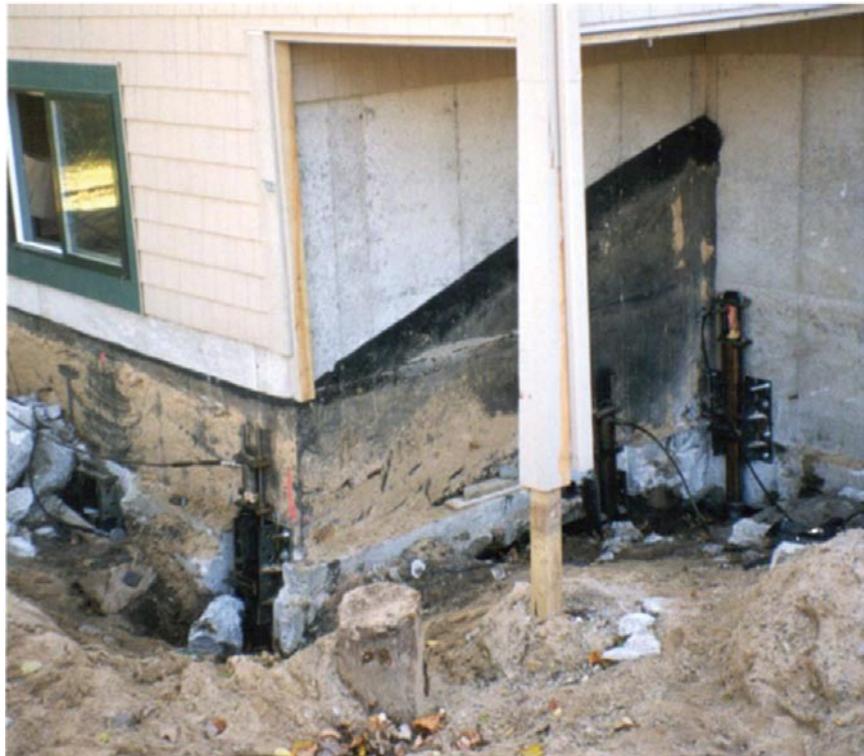
Piers 7, 8, 9 and 10 at the rear of the house near the garage during the lift. Notice the 25-ton hydraulic rams installed on each pier.

The structure was carefully lifted and was brought to virtually level. The piers were loaded and the structure lifted using 25 ton hydraulic rams that were connected to manifolds and actuated with hand pumps. One of the features of the Atlas Resistance® Continuous Lift Pier is that hydraulic rams with short strokes may be used in conjunction with the Pier to generate very large lifts.
