## **Case Study 110-8**

### **Settlement of Fill Material During Construction of an Addition to a Bank**

Atlanta, Georgia

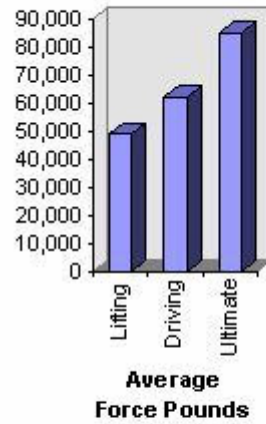
**Pier Installation Summary**

The chart above shows that ultimate pier capacity is over 36,000 pounds higher than the pier load.

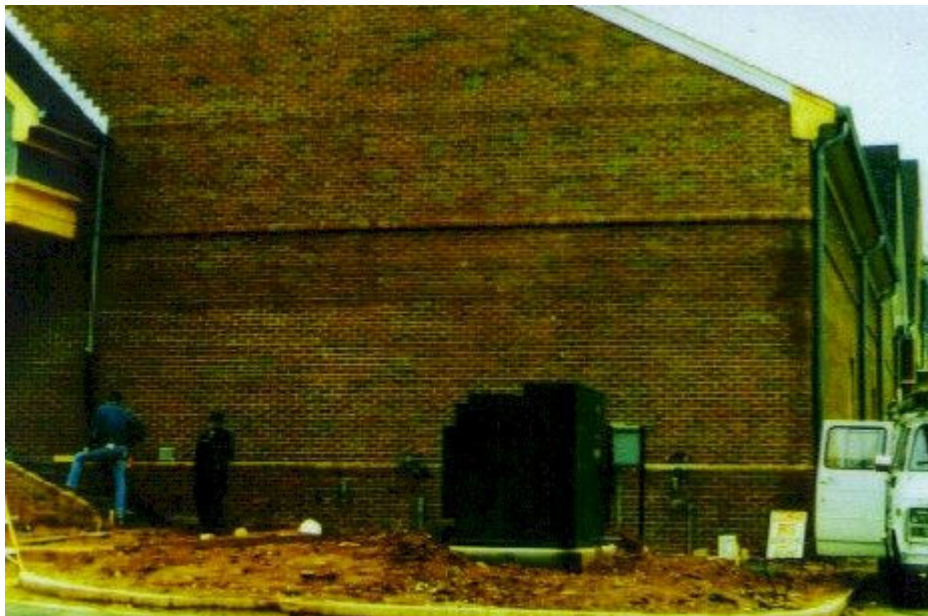
**SUCCESS!** These photographs show the masonry fracture before and after the foundation was restored with ATLAS RESISTANCE PIERS. The crack which measured  $\frac{3}{8}$  inch was completely closed.
